PANGBORN

CASE STUDY

Restoring shot blast throughput without full equipment replacement.

How Pangborn rebuilds manufacturing company's abrasive handling system to double production and reduce maintenance.

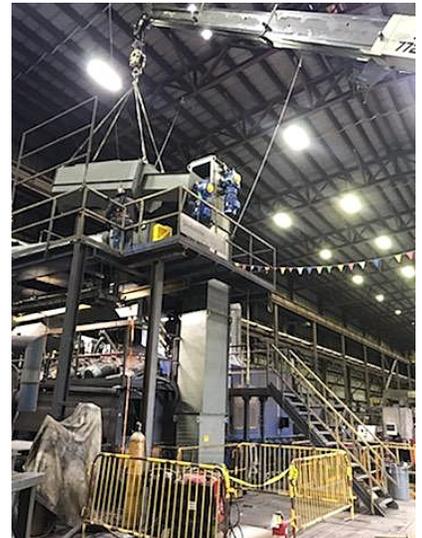
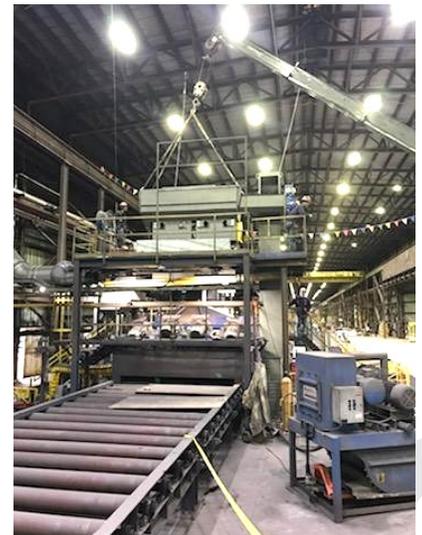
- A redesigned Pangborn elevator to move abrasive more efficiently
- A high-performance separator and scalping drum to remove flashing and foreign material
- Bin modifications and automatic curtain control to maintain steady abrasive flow

Together, these updates delivered cleaner abrasive, smoother operation, and more reliable output, even under demanding production conditions.
